**CONTINUING ELIGIBILITY INSPECTION (CEI) REPORT
FOR FLOOD CONTROL PROJECTS**

1. Project Name: Kuliouou Stream Flood Control Project

2. Date of Inspection: December 16, 2002

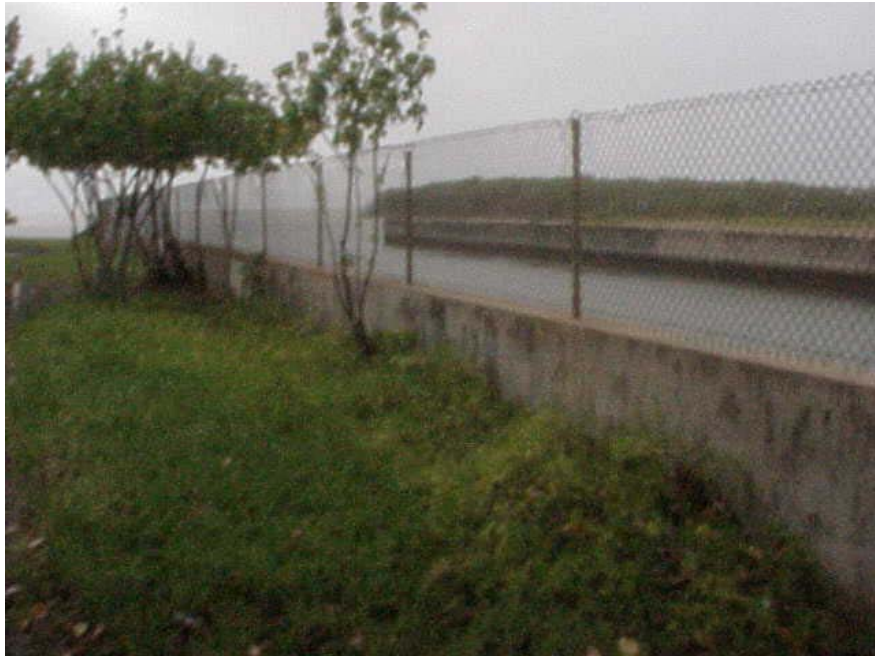
a. Sta. 4+70 fence has been replaced this year on LB and RB, approx. 200LF ®.

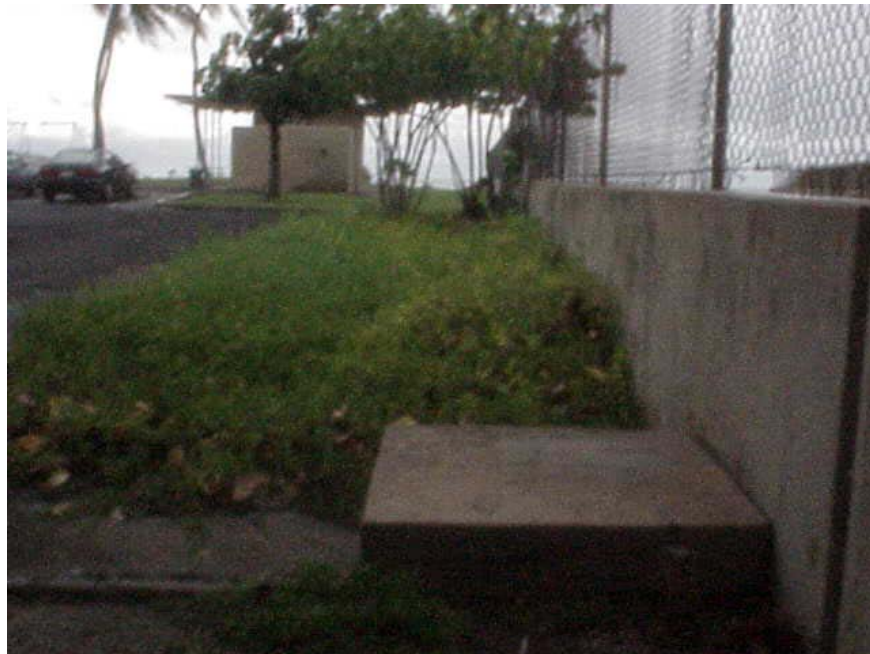
b. Sta. 4+90 flapgate still frozen, LB ®. However, it was determined the flapgate in this area was not necessary because backflow would enter into the beach park parking lot, and then sheet flow to the beach. There were also no reports of complaints in this area from a flood in the late 80's. Therefore, no maintenance is necessary.

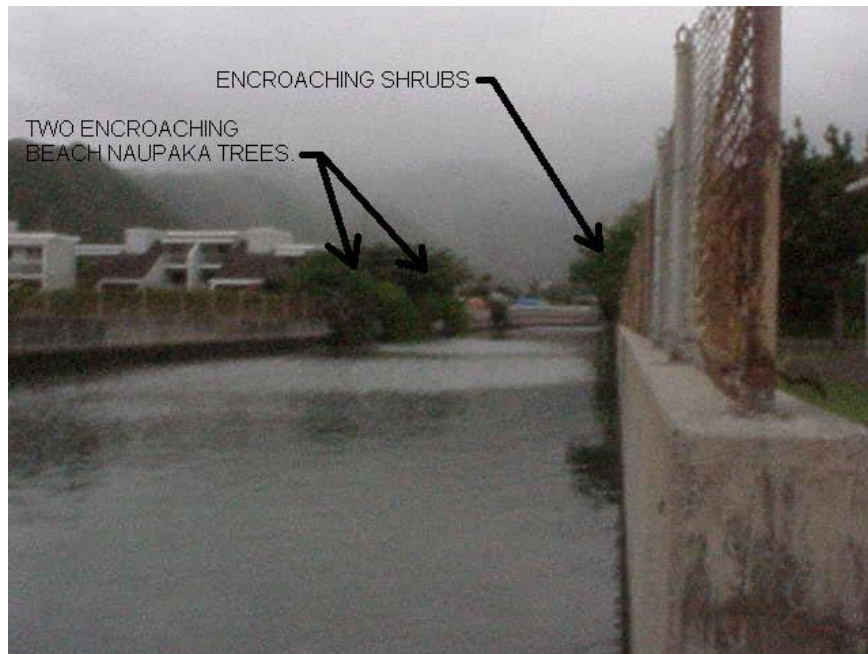
c. Sta. 8+00, RB, remove two naupaka trees from sidewall of channel. Remove encroaching shrubs from left bank of channel sidewall ®.

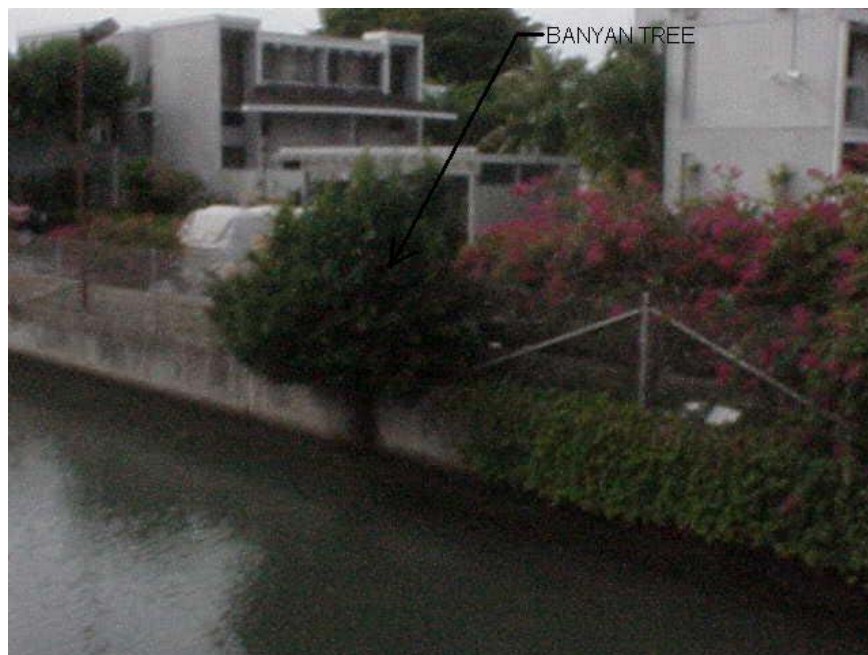
d. Sta. 7+80, RB, remove banyan tree ®.

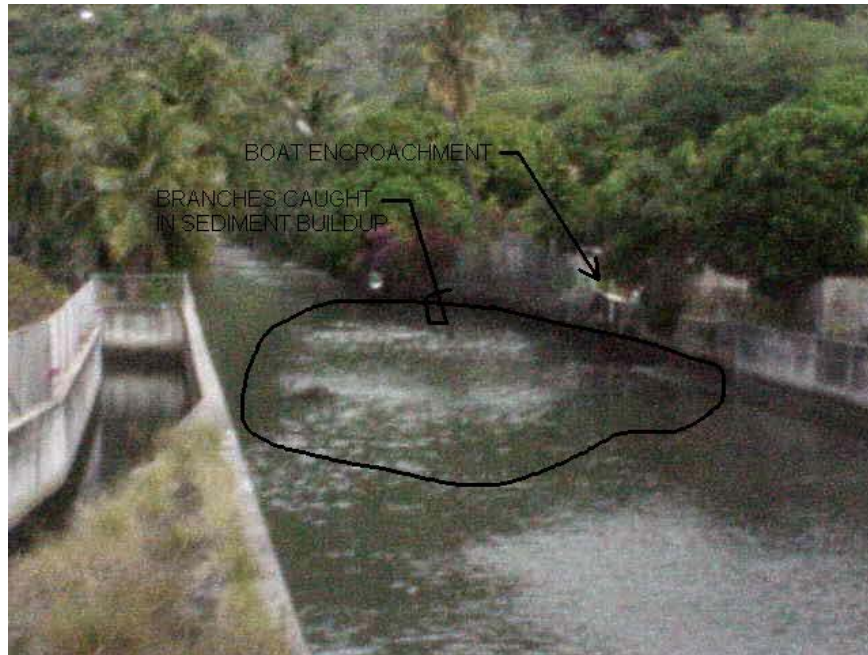
e. Sta. 13+20, LB, remove boat encroachment. Monitor sediment level in channel; branches inside the channel invert are caught by the sediment buildup.

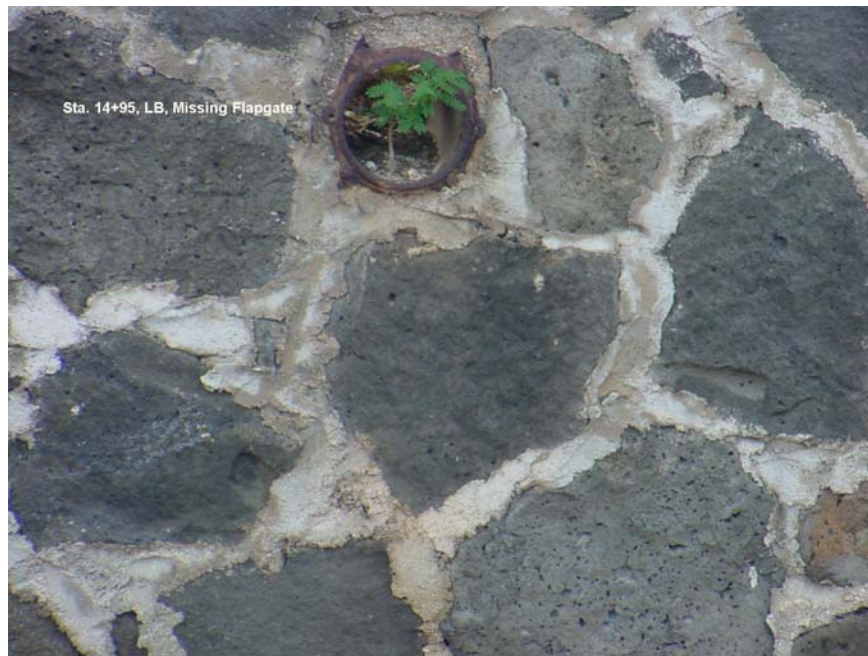
f. Sta. ~~14+95~~ 18+53, LB, Replace missing flapgate. Unable to inspect due to tide rising in channel ®.

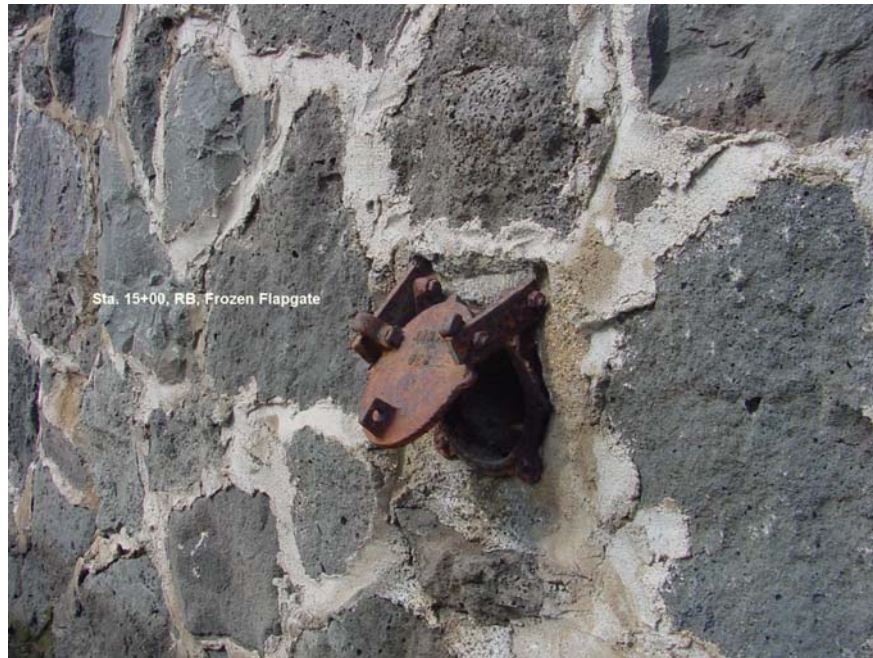
g. Sta. ~~15+00~~ 18+58, RB, Repair frozen 8" flapgate. Unable to inspect due to tide rising in channel ®.

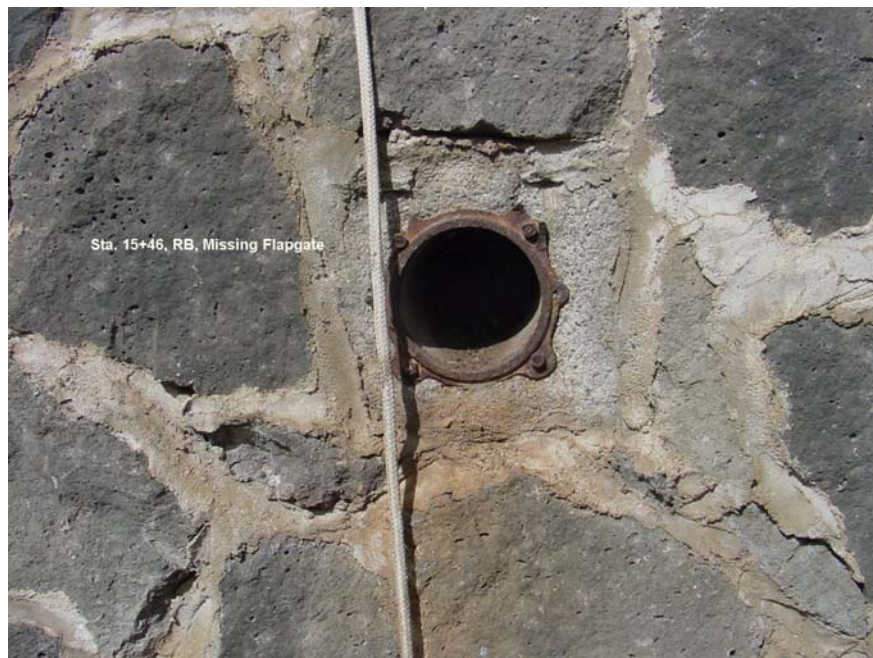
h. Sta. ~~15+46~~ 19+04, RB, replace missing 8" flapgate ®.

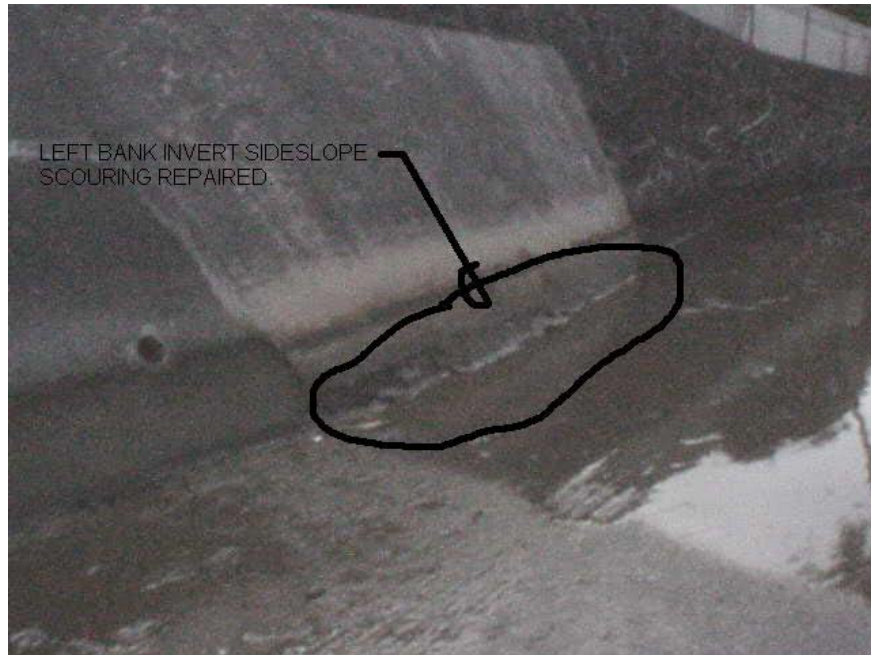
i. Sta. ~~15+60~~ - Sta. ~~15+7~~ 19+20, LB, sideslope/invert concrete scouring has been repaired. Continue to monitor condition of post repair job ®.

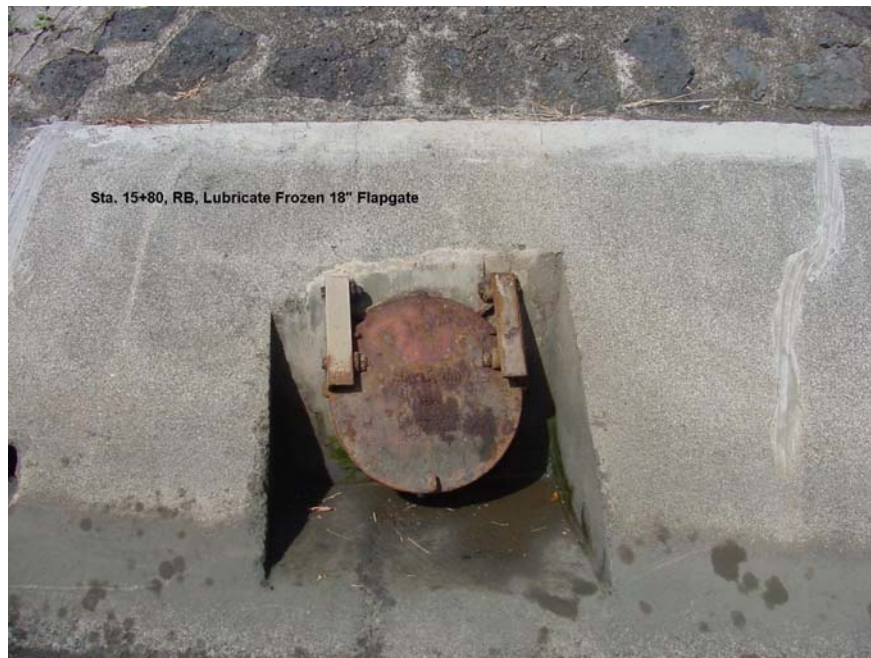
j. Sta. ~~15+80~~ 19+24, RB, lubricate frozen 18" flapgate ®.

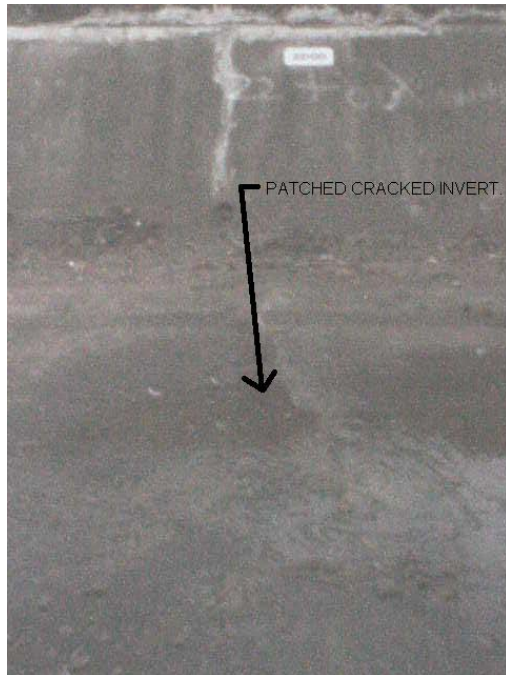
l. Sta. 22+00, cracked invert has been patched. Continue to monitor post condition ®.

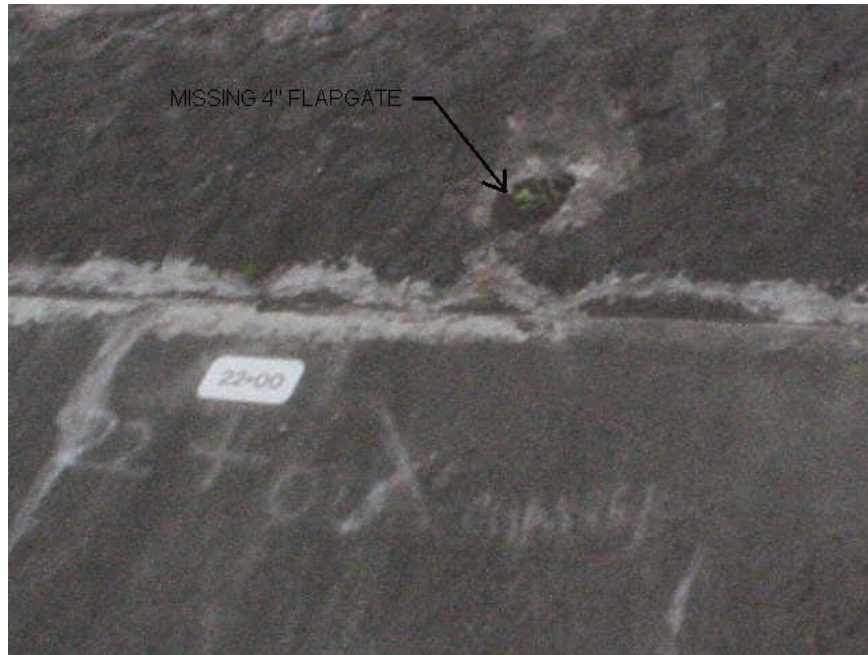
m. Sta. 22+00, RB, replace missing 4" flapgate and clean out drain line.

Station	Location	Defects
NA	Typical	Continue to remove vegetation from invert weep holes throughout the project. Suggest the investment and use of an auger.
NA	Typical	Continue to lubricate all flapgates.
NA	Typical	Continue to remove debris from invert throughout the project.
8+00	RB	Remove two encroaching beach naupaka trees.
8+00	LB	Remove encroaching shrubby vegetation overhanging bank.
7+80	RB	Remove banyan tree.
13+20	LB	Remove hanging boat encroachment.
13+20	channel	Monitor soil sediments which are trapping branch debris in channel.
18+53	LB	Replace small diameter missing flapgate.
18+58	RB	Repair small diameter frozen flapgate.
19+04	RB	Replace small diameter missing flapgate.
19+20	LB	Continue to monitor post condition of repaired concrete scouring at toe of wall.
19+24	RB	Lubricate frozen 18" flapgate.
22+00	channel	Continue to monitor post condition of patched cracked invert.
22+00	RB	Replace small diameter missing flapgate and clean out drain line.

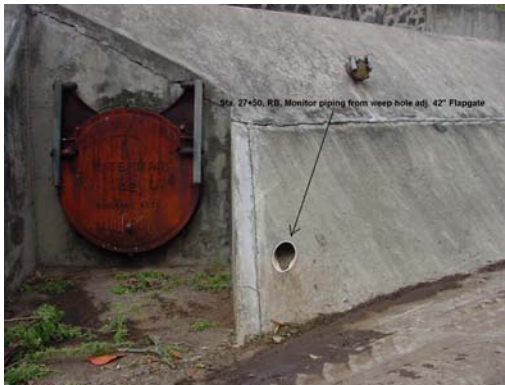
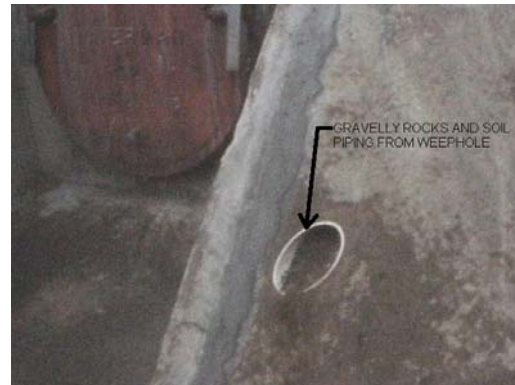
n. Sta. 27+50, RB, monitor gravelly rock and soil piping from weephole. Picture on left is from FY02. Picture on right is from FY03. Condition seems to be stable.

27+50	RB	Monitor piping from weep hole.
29+50	RB (adjacent typical areas)	Redo sidewall concrete patching with improved concrete mixture.
31+85	LB	Redo sidewall concrete patching with improved concrete mixture.
29+50	RB	Caulk and monitor separation at top of

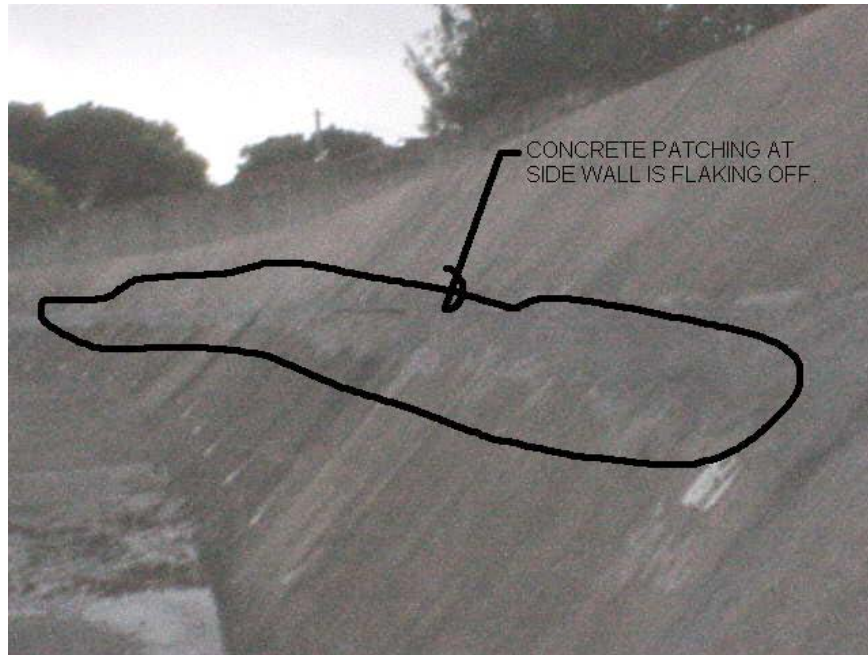
o. Sta. 29+50, RB, and Sta. 31+85 LB, redo concrete patching. Patchwork is flaking off sidewall probably due to excessive water content in concrete patch mixture. (Typical for all other patchwork areas with poor concrete mixture.)

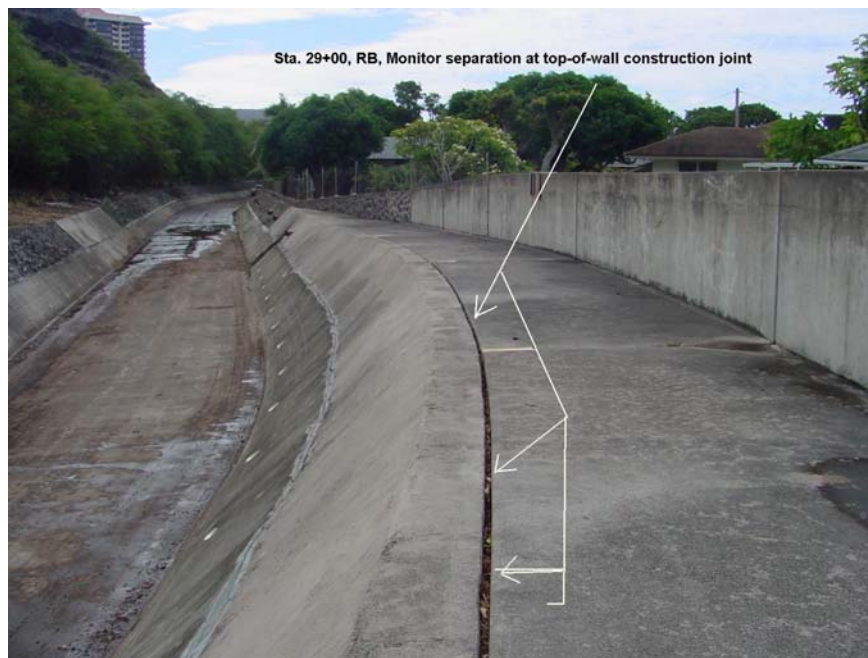
p. Sta. 29+50, RB, Top-of-wall, Caulk construction joint and monitor possible separation ®.

construction joint.
--	---------------------
